Jury's Gap – 1.10.08 – 1 hour before high tide 12.21 pm – Loss of shingle and exposure of structures within 24 hours!

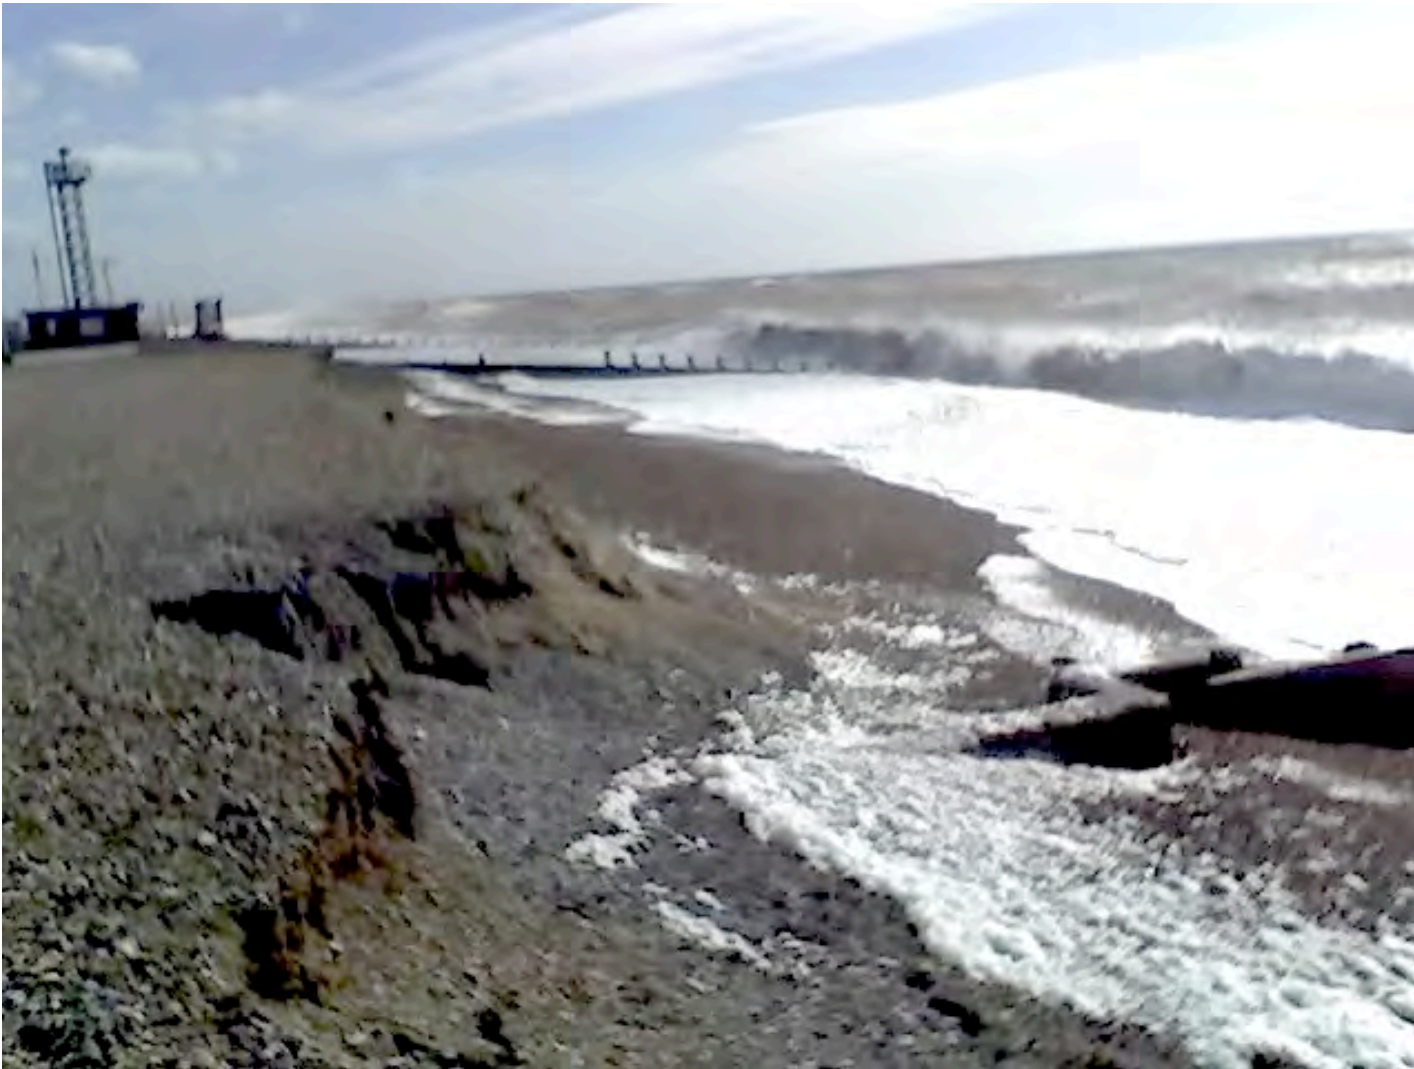
All shingle ridges lost in one day! What a waste of money!

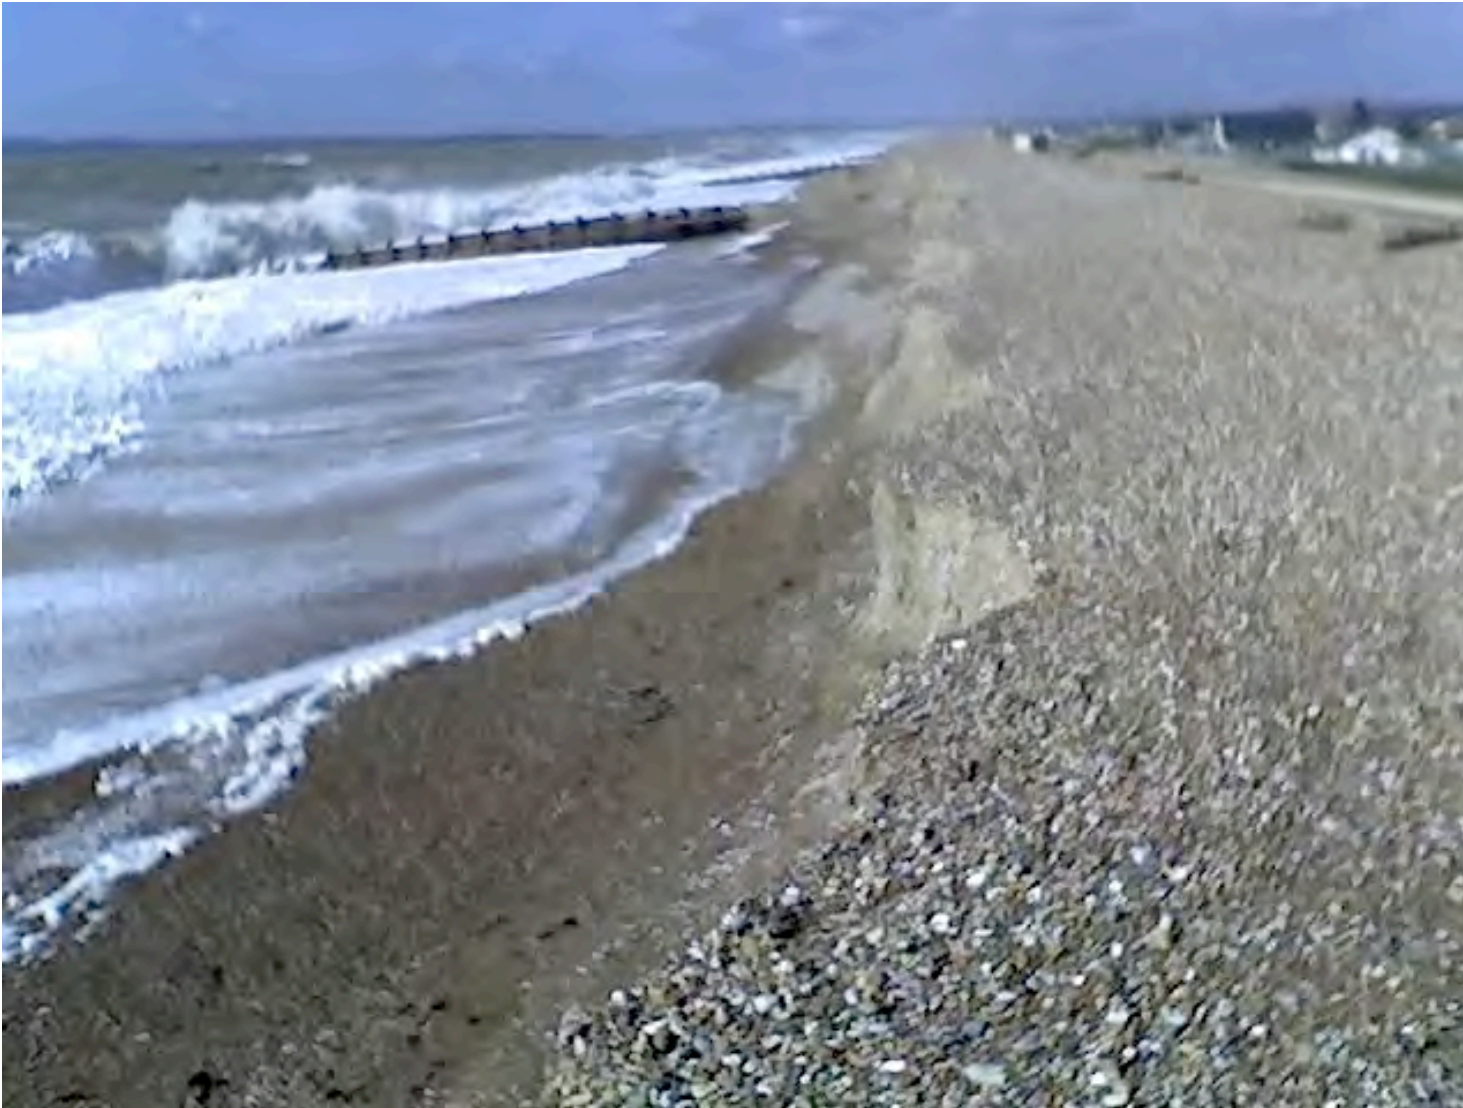
Jury's Gap – 1.10.08 – 1 hour before high tide 12.21 pm – Loss of shingle and exposure of structures within 24 hours!

1960's sea wall now exposed with 19 courses (yesterday there were 9 courses exposed) and more shingle lost from the embankment!

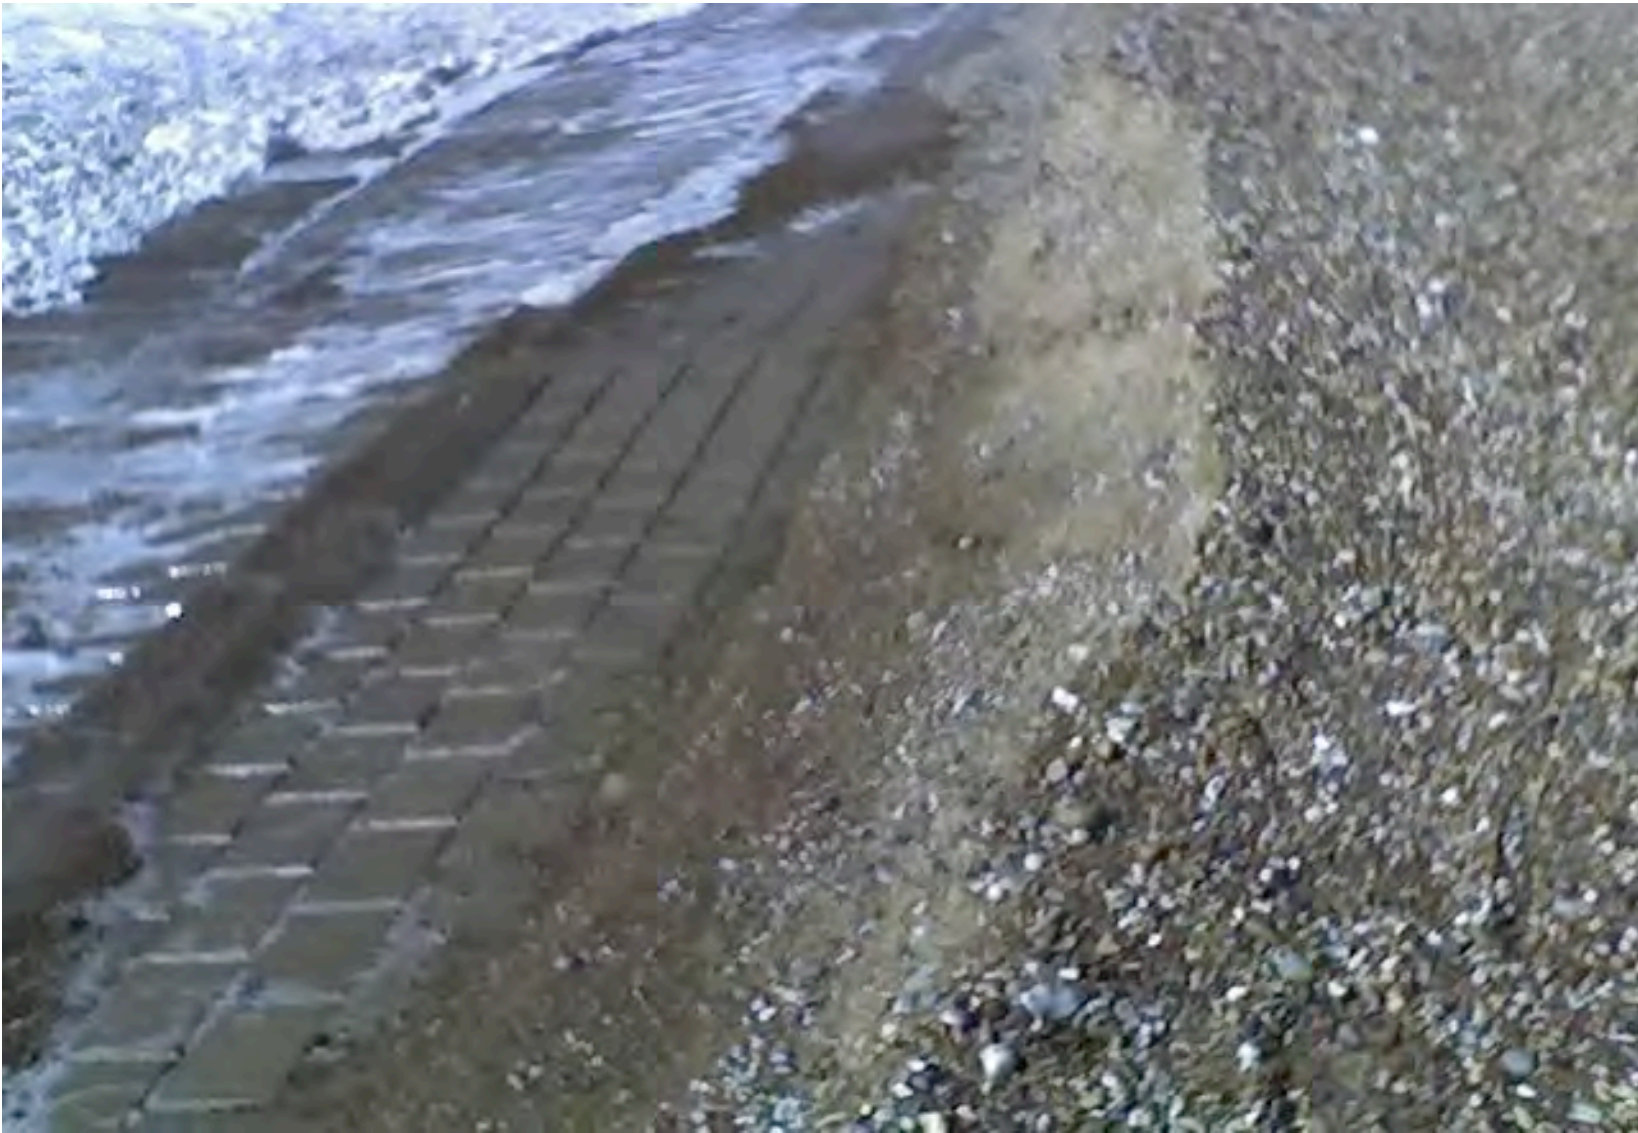
Jury's Gap – 1.10.08 – 1 hour before high tide 12.21 pm – Loss of shingle and exposure of structures within 24 hours!

Embankment just crumbling away – 1 hour yet to go for high tide!

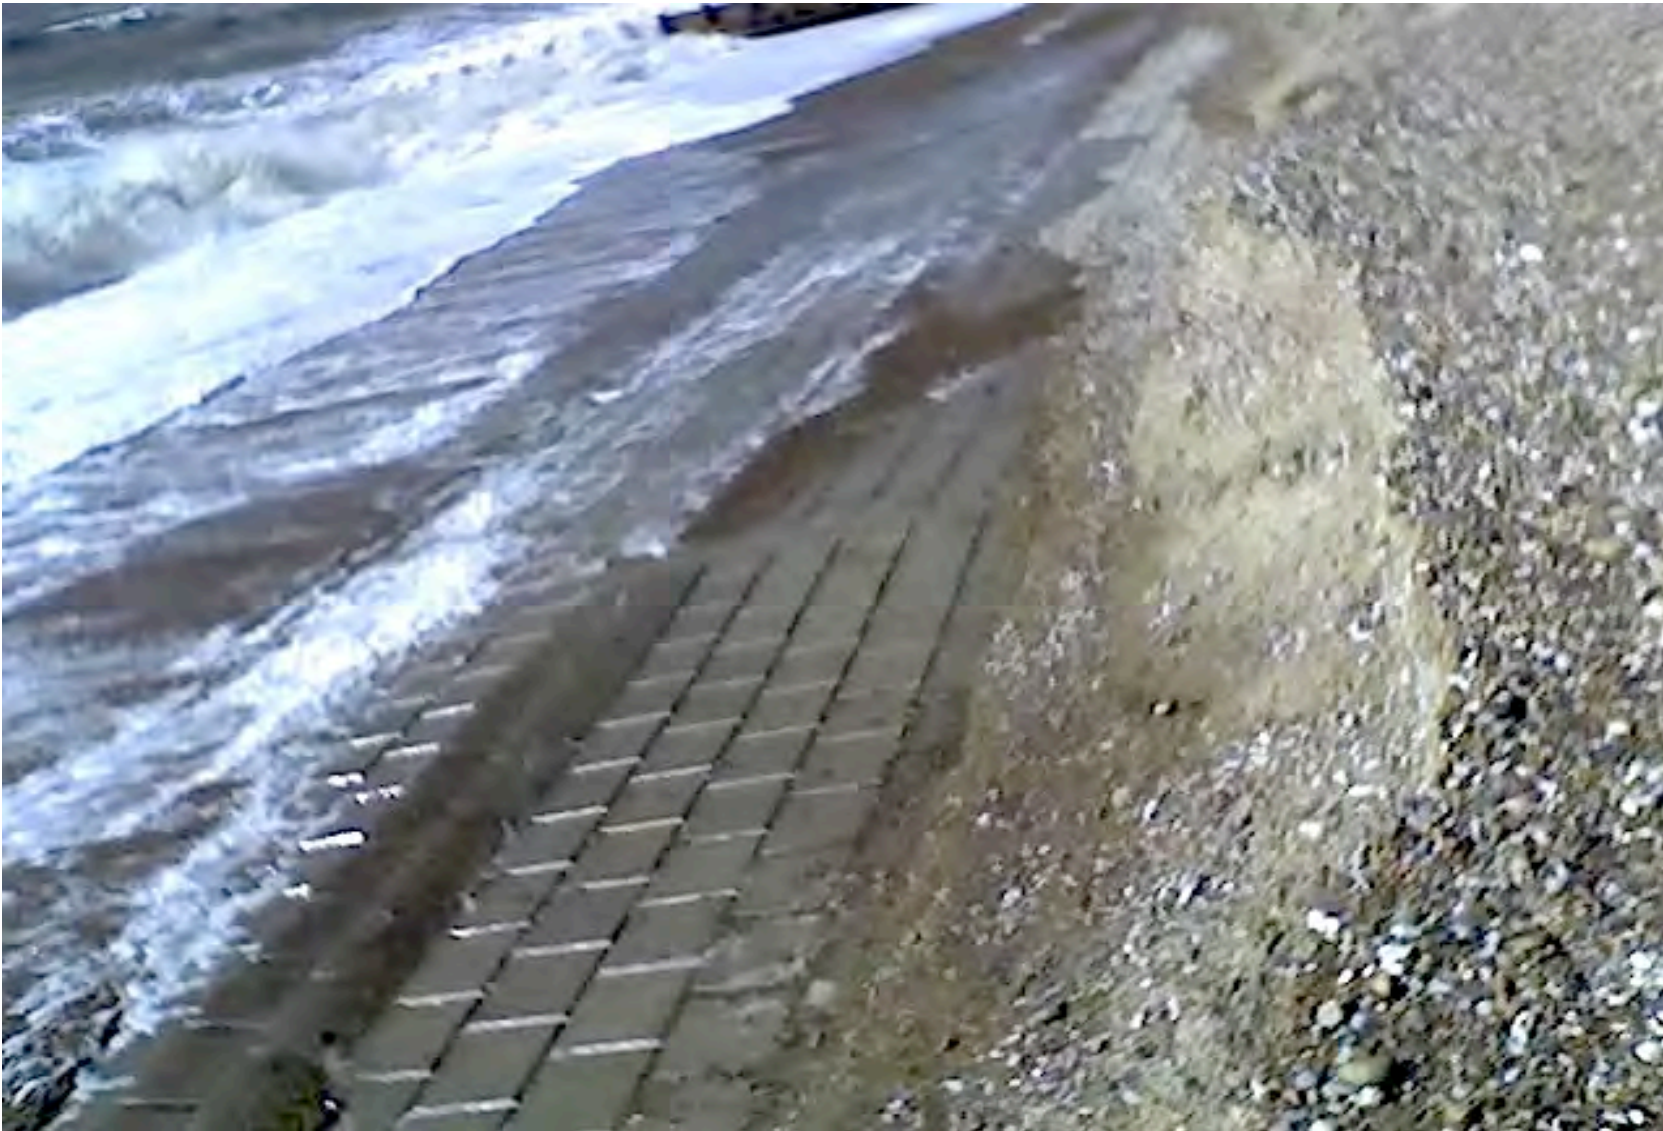
Jury's Gap – 1.10.08 – 1 hour before high tide 12.21 pm – Loss of shingle and exposure of structures within 24 hours!

10 new courses exposed today!

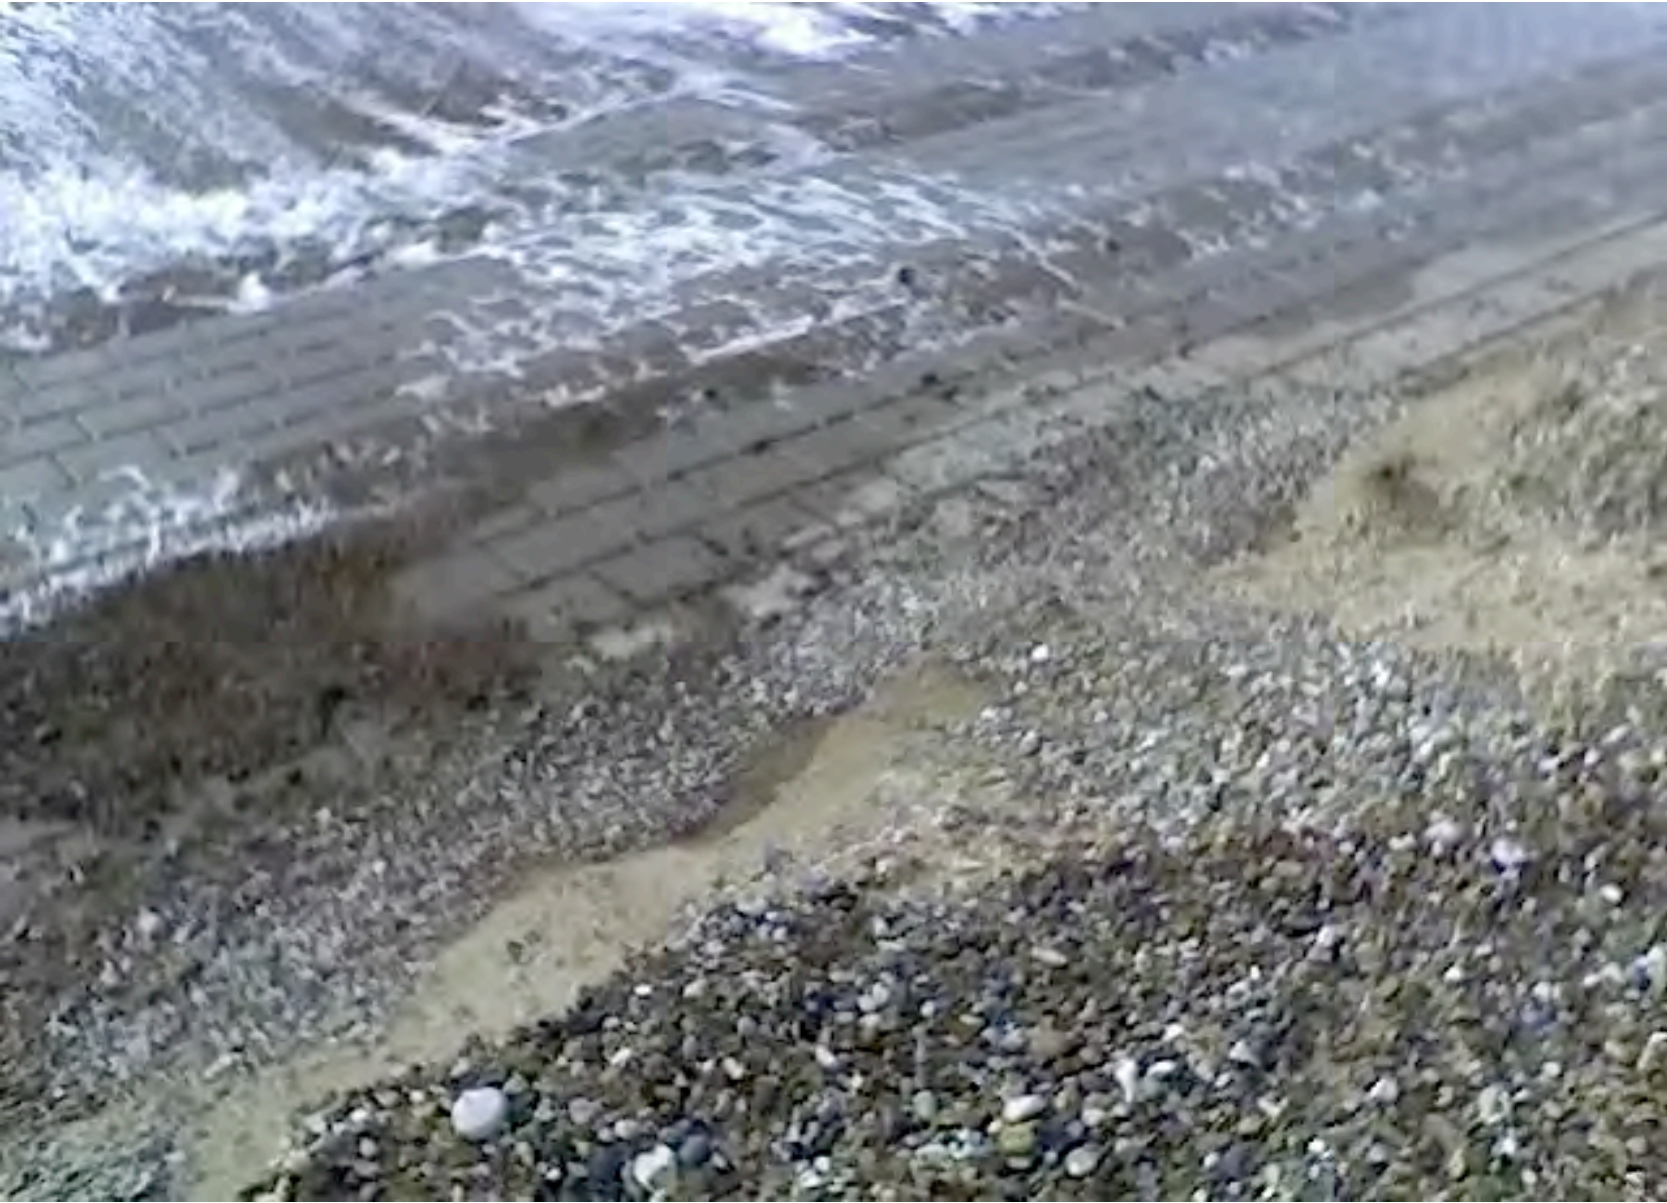
Jury's Gap - 1.10.08 - 1 hour before high tide 12.21 pm - Loss of shingle and exposure of structures within 24 hours!

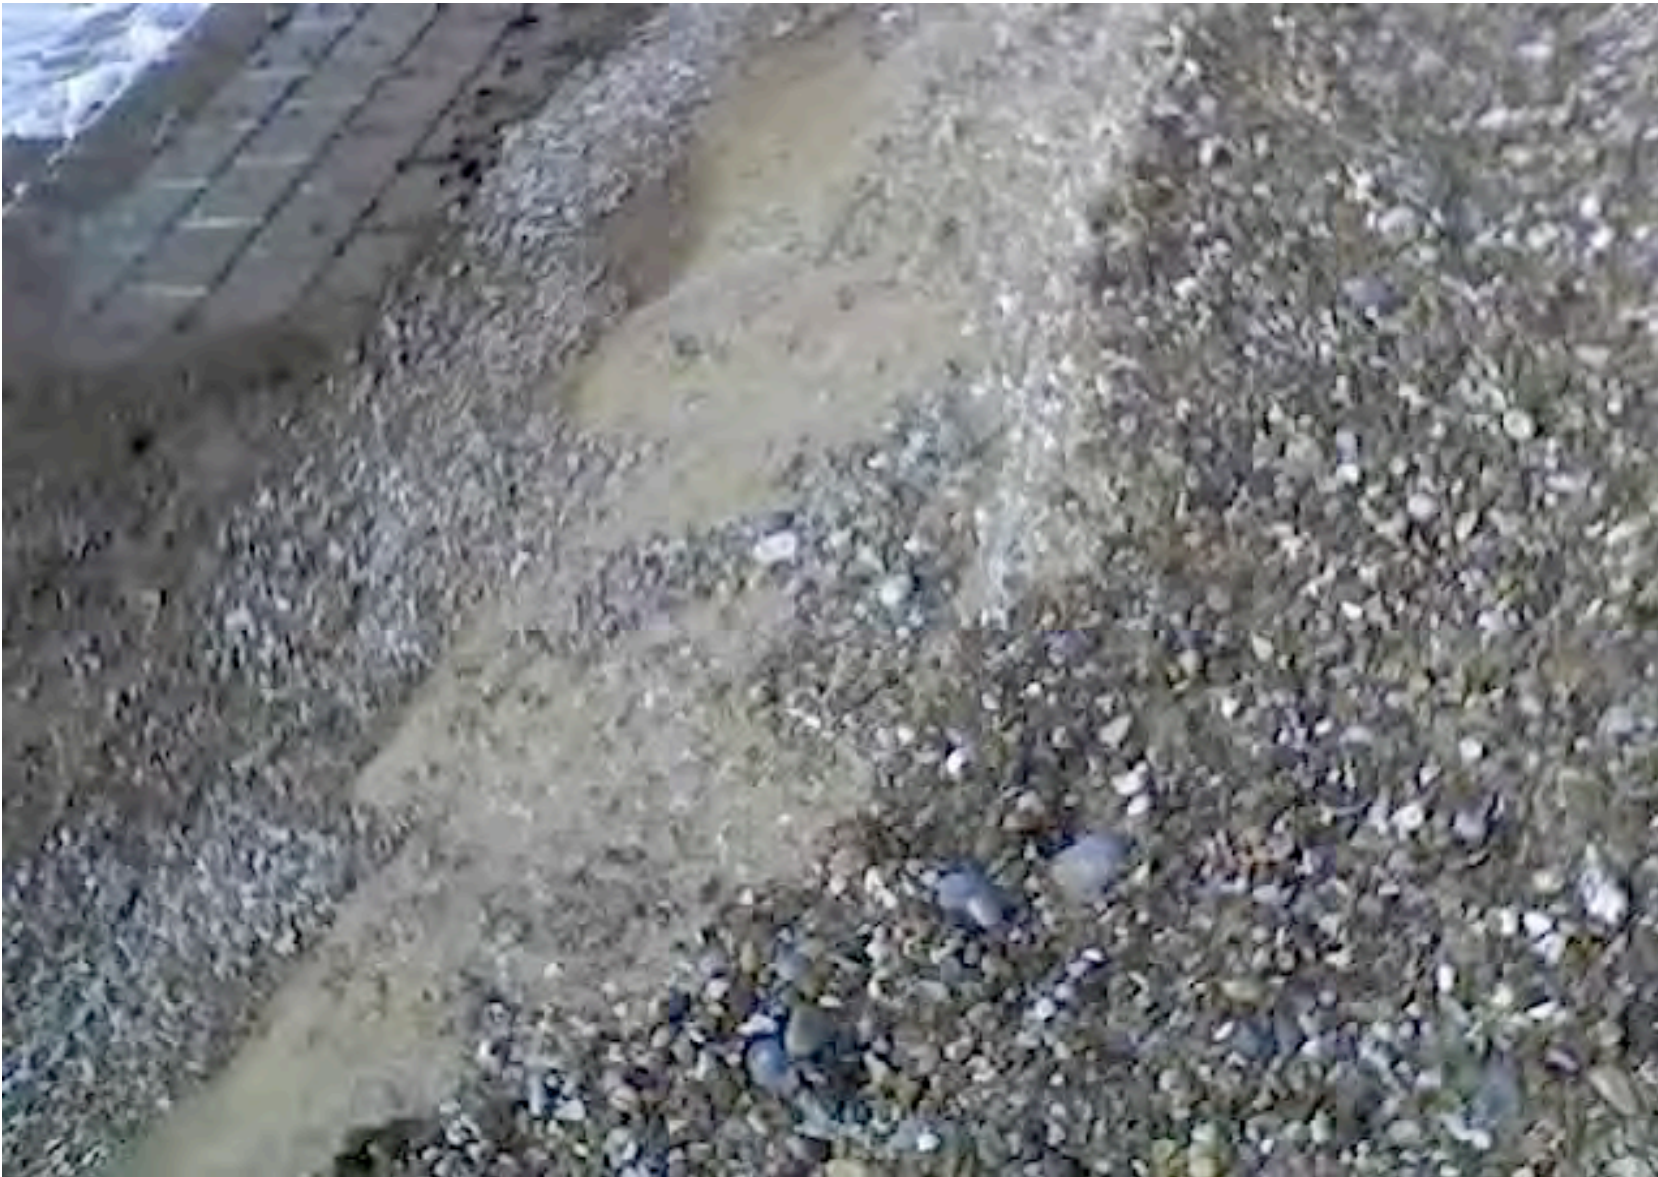
Jury's Gap – 1.10.08 – 1 hour before high tide 12.21 pm – Loss of shingle and exposure of structures within 24 hours!

Evidence of sandy material rather than correct shingle quality

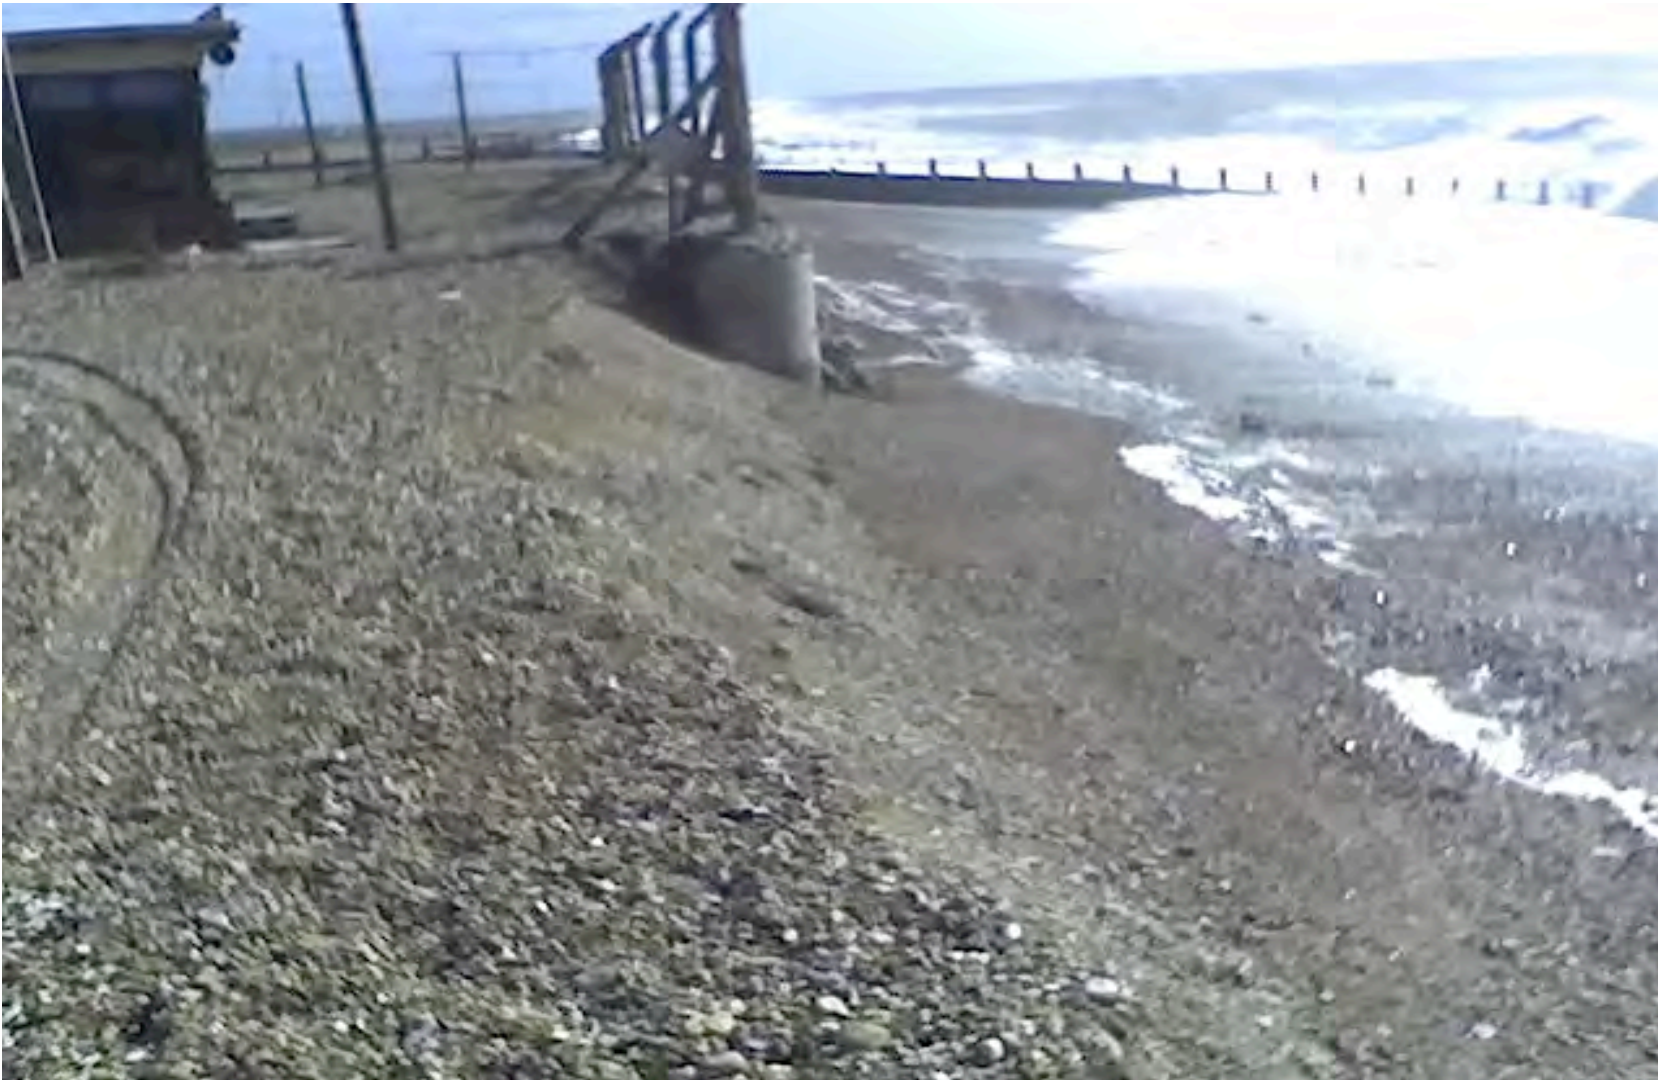
Jury's Gap – 1.10.08 – 1 hour before high tide 12.21 pm – Loss of shingle and exposure of structures within 24 hours!

MOD Lookout – all shingle ridges gone – base of structure totally exposed

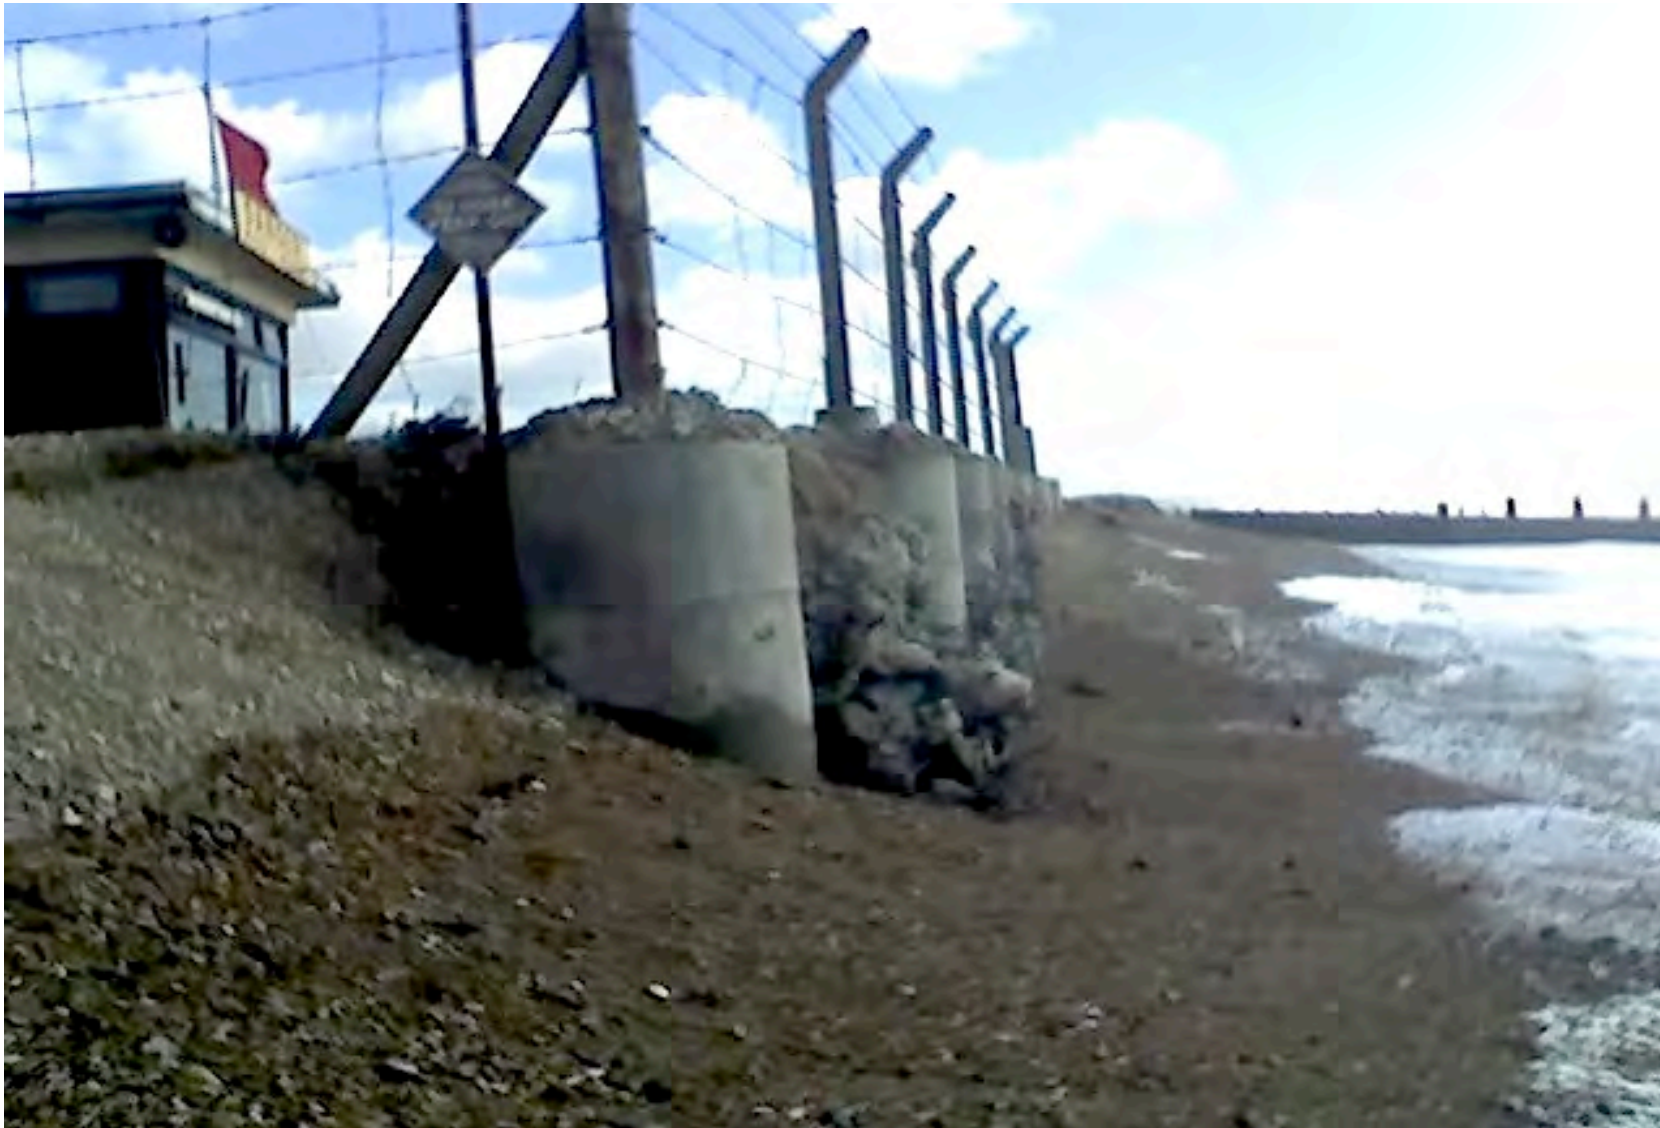
Jury's Gap – 1.10.08 – 1 hour before high tide 12.21 pm – Loss of shingle and exposure of structures within 24 hours!

Concrete posts and rock gabions clearly visible

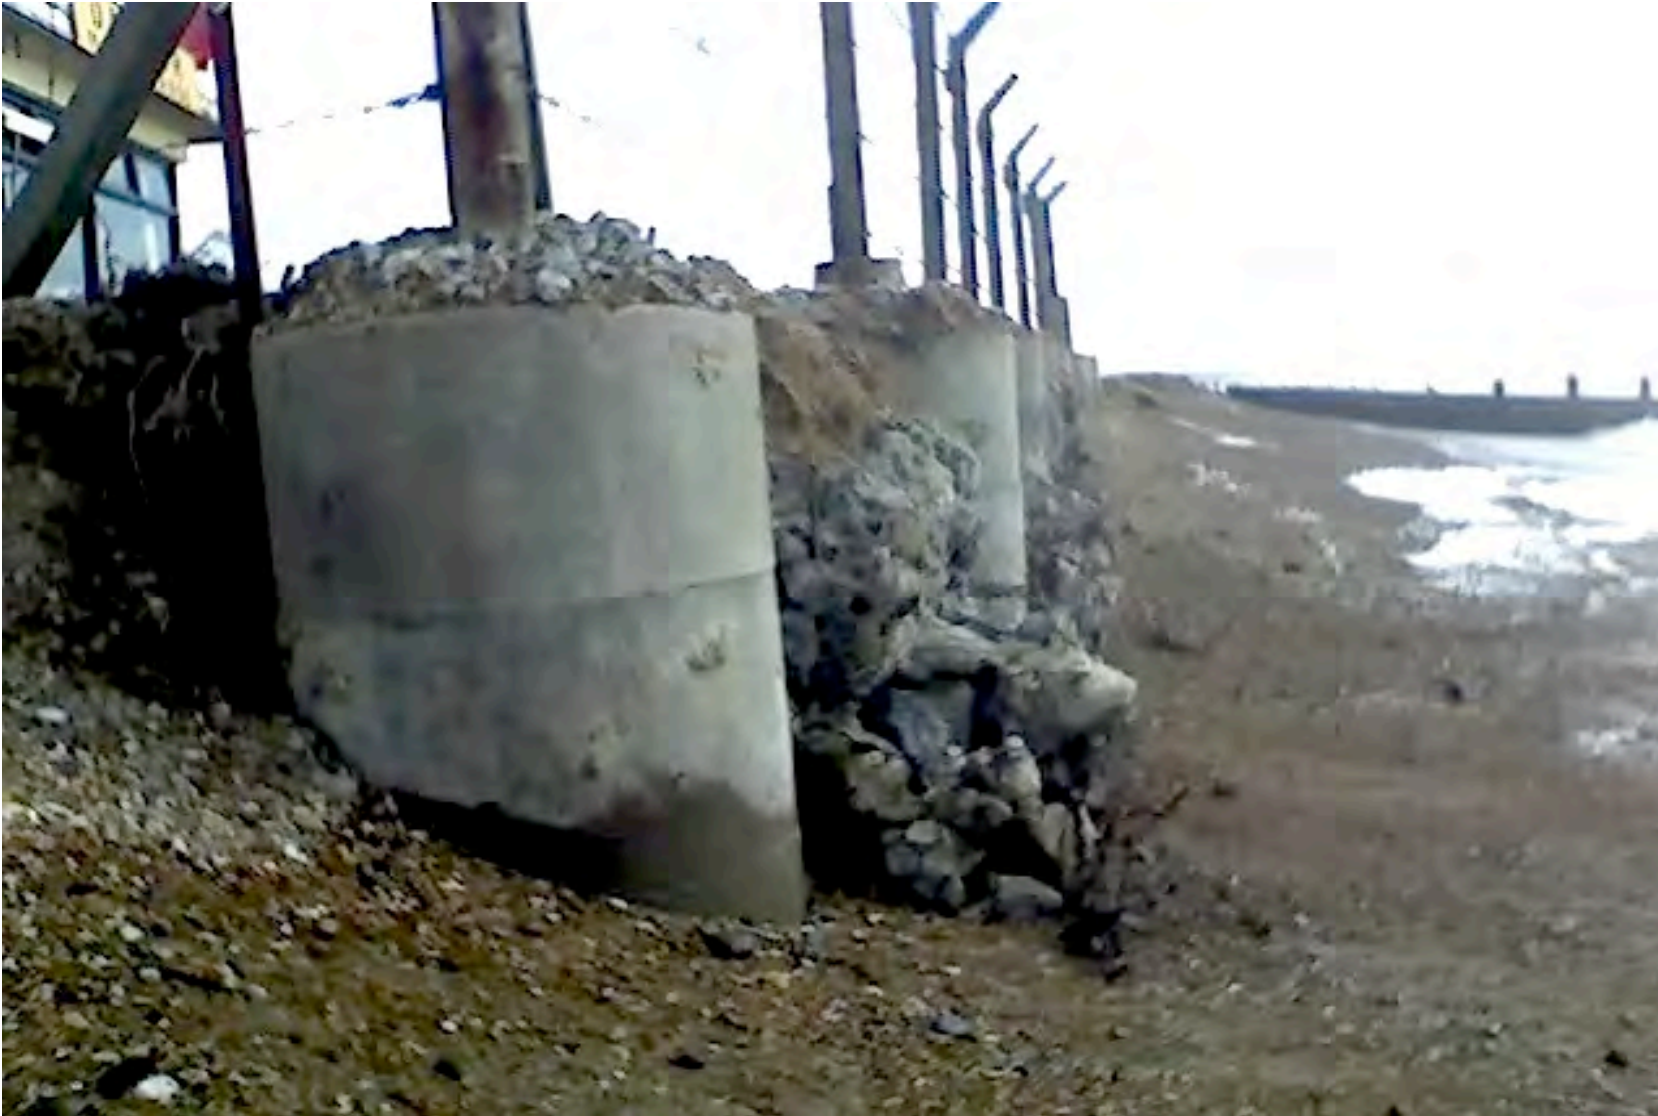
Jury's Gap – 1.10.08 – 1 hour before high tide 12.21 pm – Loss of shingle and exposure of structures within 24 hours!

Total loss of access around the MOD Lookout!
